Gillingwood Hall, near Richmond, North Yorkshire,
and its historic garden:
an interim report

Tim Gates and Trevor Pearson

Scarborough Archaeological and Historical
Society
Report 62: 2024

National Grid Ref NZ 1710 0475
National Grid co-ordinates 41710 50475
North Yorkshire HER No. MNY40333

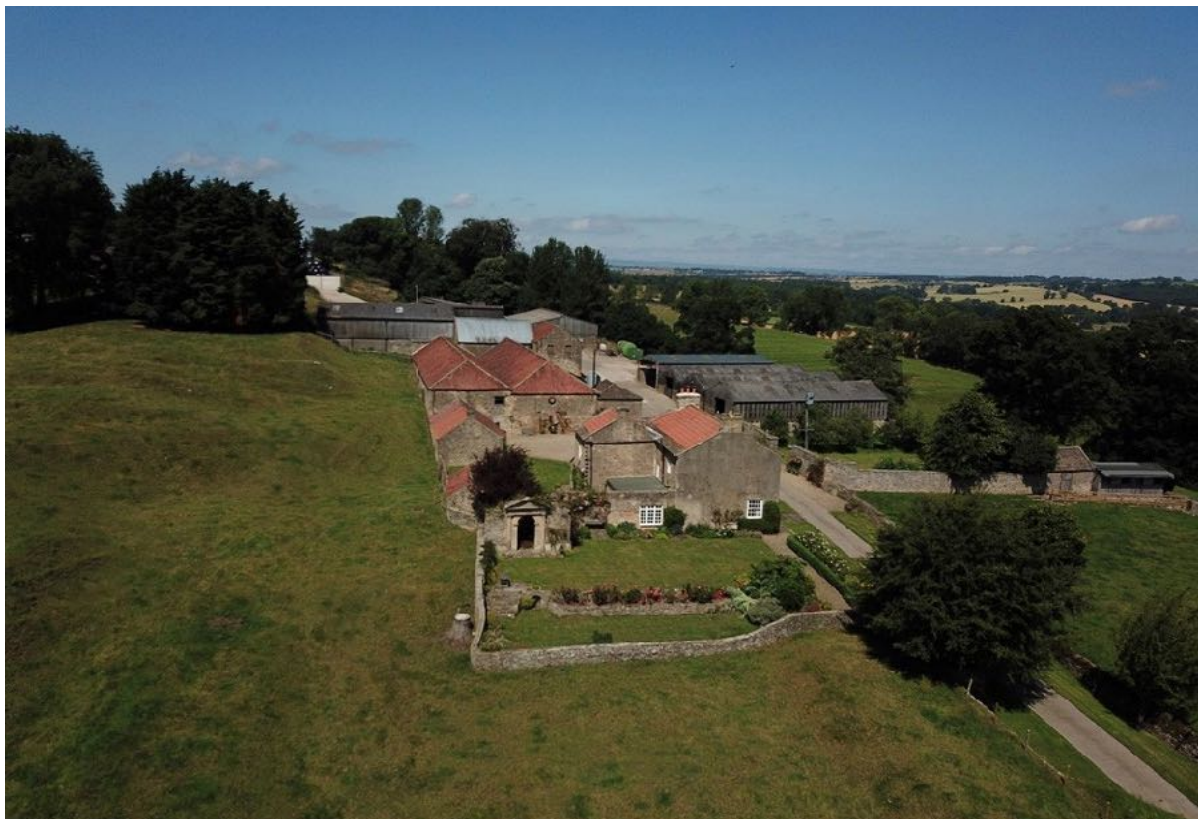
Gillingwood Hall viewed from the south-east. Photograph by D. Went, 22 July 2019.

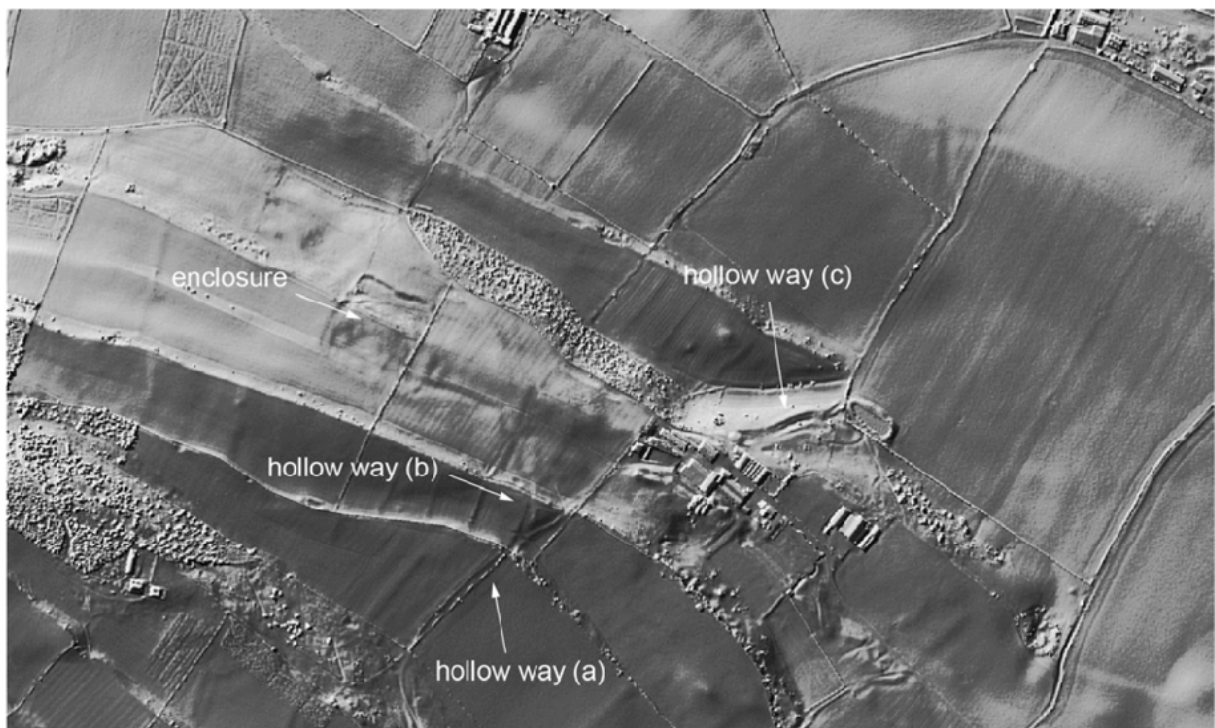
Figure 3. Lidar image based on Environment Agency data. (Map contains public sector information licensed under the Open Government Licence v3.0.).

There is, however, clear evidence of earlier settlement and land use within a radius of 1km. For example, in a field called 'The Ashes', 500m NE of Gillingwood, at NGR NZ 166 049, there is a ploughed down earthwork, consisting of a sub-rectangular enclosure with dimensions of the order of 150m by 120m. This earthwork is visible on both lidar imagery and Google Earth, and is also apparent on the ground (Fig. 3).

The N side of the enclosure is formed by a substantial bank with an inner ditch but otherwise the enclosure is only intermittently visible as a residual earthwork. There appears to be an entrance in the E-facing side but no surface traces of occupation are apparent in the interior. Nevertheless, the size and shape of the enclosure suggest that it may represent a settlement of the late Iron Age or Roman periods.

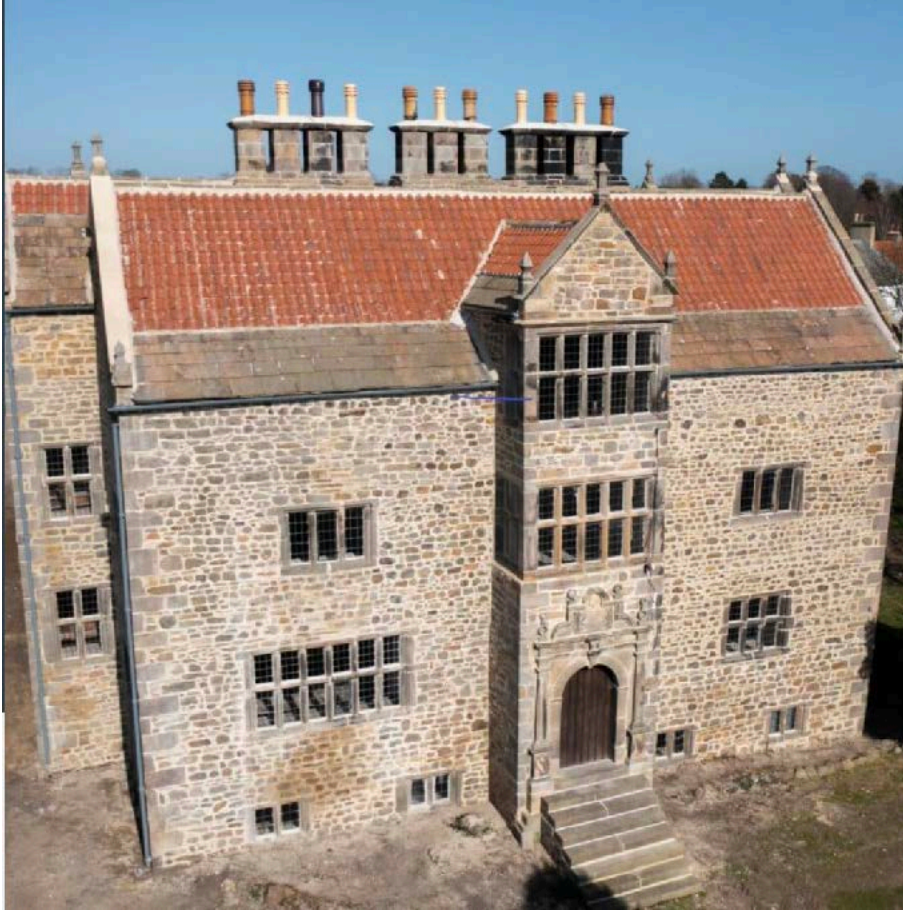
Figure 5. Gainford Hall, county Durham. Photograph courtesy of Lord Barnard and the Raby Estate.

A building of this type, of double-pile construction with lateral stair turrets, is a rarity in the North and the plan may have been developed in the late 16th century by John Thorpe, a London-based architect (Nicholas Cooper 1999, 162-164). Surviving local parallels are few and far between, the most significant being Gainford Hall, in county Durham (Fig. 5), and Gaythorne Hall, in Westmorland. As it happens, Gaythorne belonged to the Bellinghams of Levens Hall, in Westmorland, to whom the Whartons were related by marriage.

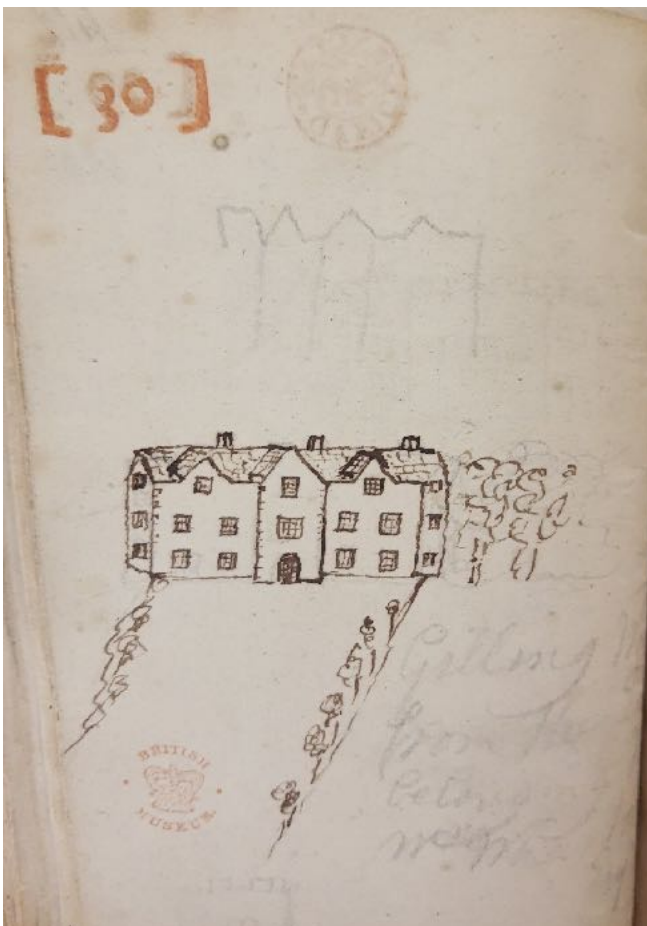
Figure 6. John Warburton's thumbnail sketch of Gillingwood Hall, c. 1718. Copyright the British Library Board.

In one of Warburton's notebooks in the British Library there is a thumbnail sketch of Gillingwood annotated in pencil 'Gilling Wood from the East belonging to Mr Wharton Esq' (Fig. 6; British Library Lansdowne MS 911/4 f. 359d). This dispels any doubt there might otherwise be that it was the E front of the house that Buck drew. In other words, the Jacobean house faced E, whereas the later farmhouse faces N.

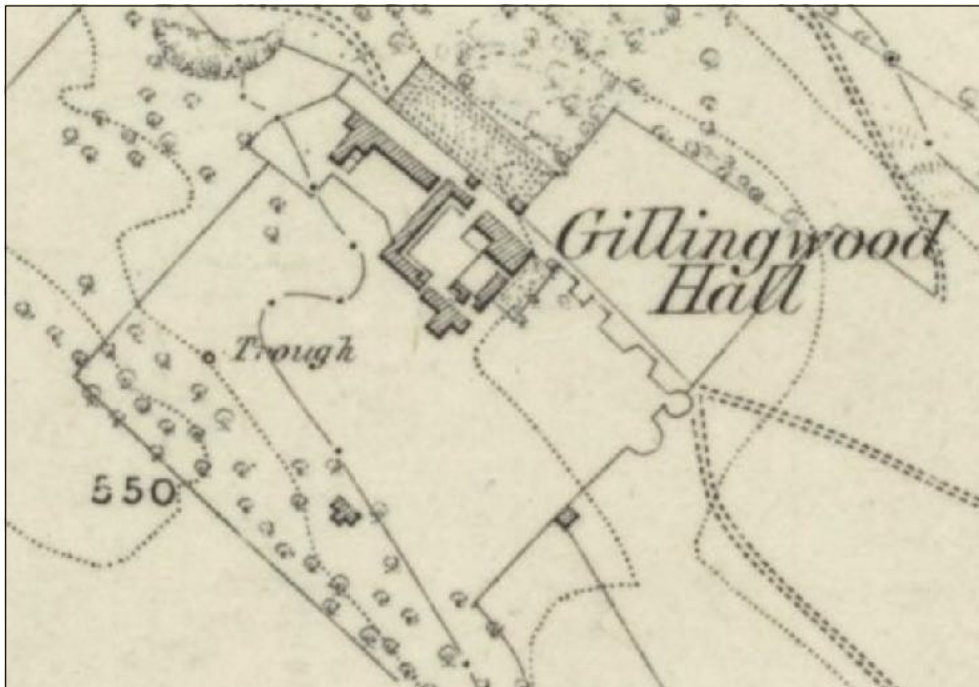
Figure 9. Extract from the OS first edition of the six-inch map, surveyed in 1854/7. (Reproduced by permission of the National Library of Scotland).

The first edition of the OS six-inch (1:10,560 scale) map, surveyed in 1854 and published in 1857, is the earliest printed map to show Gillingwood Hall and its accompanying farm buildings accurately and to scale (Fig. 9).

What are presumably barns, animal sheds, cart houses and the like are arranged round a large yard to the W and S of the farmhouse. These include a detached, T-shaped building with a short arm projecting to the SW. Further to the NW is another range of buildings and beyond that a quarry.

The 1857 six-inch map also shows the pavilion, the temple-like 'summerhouse' and the bastioned retaining wall which bounds the formal garden on its NE and SE sides. The free-standing doorway on the lawn to the S of the farmhouse is not depicted, however, nor are the garden terraces.

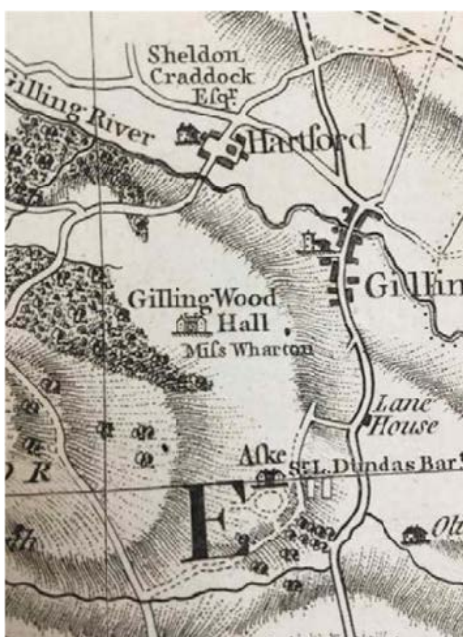
Figure 13.
Extract from Thomas Jefferys' Map of Yorkshire,
2nd edn., 1775

The first edition of Thomas Jefferys' *Topographical Survey of the County of York* (1771) depicts 'Gilling Wood Hall' in a similar manner to that employed by Warburton. The second edition, published four years later, in 1775, adds the name 'Miss Wharton' to the image (Fig. 13). As the privilege of having their names printed on the map was something that patrons had to pay for, we can assume that 'Miss Wharton' was keen to have her name publicly associated with the property, perhaps as an assertion of the family's continuing ownership. This Miss Wharton would have been the Margaret Wharton who inherited Gillingwood after the death of her brother, William, in 1750.

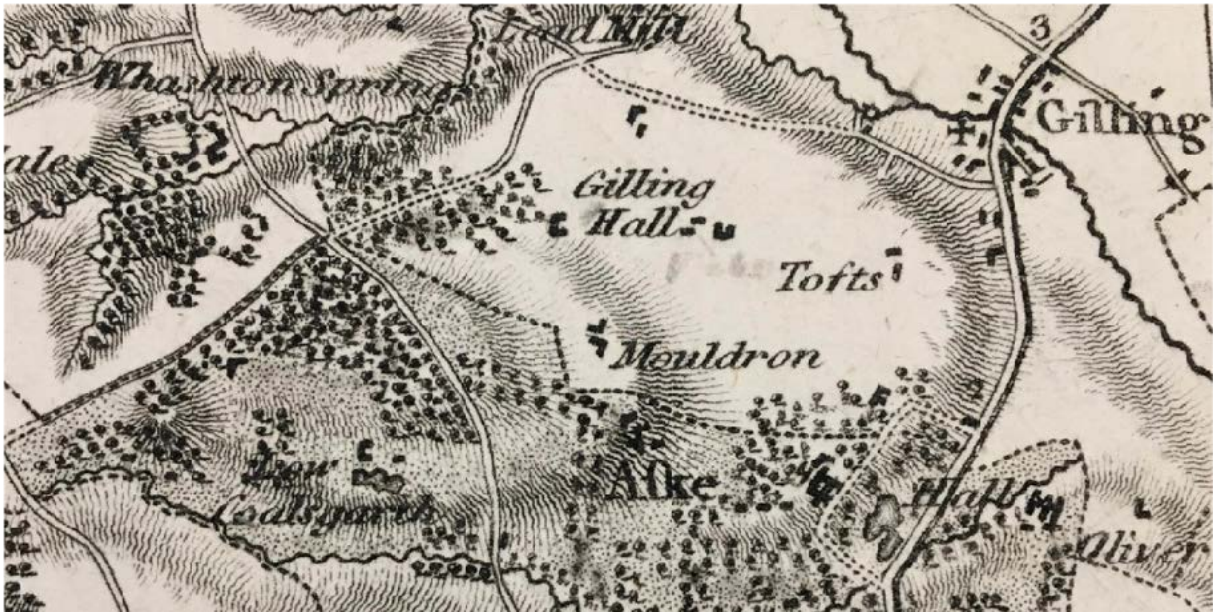
Figure 15. Extract from William Greenwood's Map of Yorkshire, 1817/18.

Gilling Hall' is shown on William Greenwood's *Map of Yorkshire* (1817/18) as a generalised group of dispersed buildings (Fig. 15). The depiction of the buildings is clearly not intended to be realistic and their plan should not be taken as such.

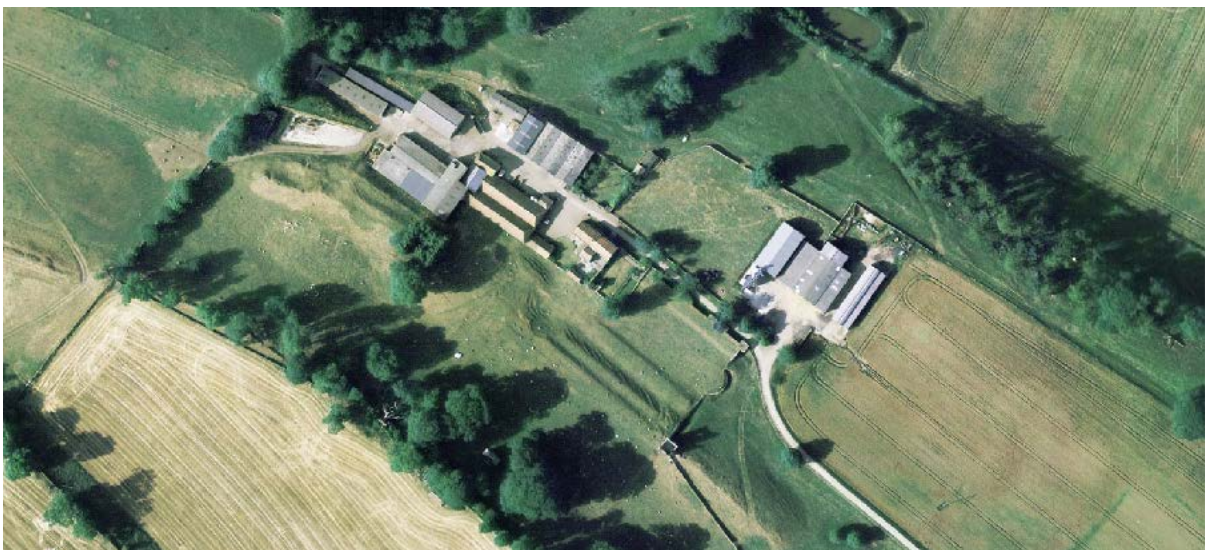
Figure 16. Gillingwood as seen on Google Earth (July 2006 imagery).

As recorded on the plan (Fig. 2), and on Google Earth (Fig. 16), three terraces descend the slope SW of the large parterre which extends from the lawn beside the farmhouse to the half-moon bastion in the retaining wall on SE side of the garden. NE of the parterre, a fourth terrace is supported by the bastioned wall beside the lane.

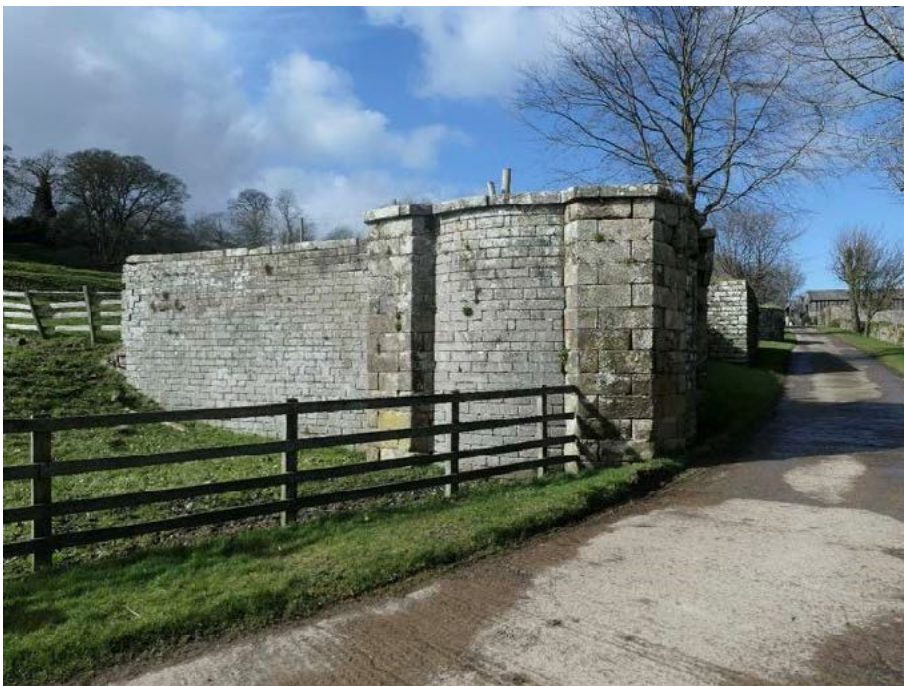
Figure 17. The corner turret and the bastioned wall beside the lane.

Approaching Gillingwood along Old Hall Lane, the visitor is confronted by the massively-built bastioned stone wall which forms the perimeter of the garden on its SE-facing side (Fig. 17). Standing to a maximum height of 3.5m at the turret on the corner, the wall is built of neatly coursed ashlar blocks with ridged tooling on their face (Fig. 18).

Closer to the house, where the wall runs parallel with the lane, the masonry is of noticeably less good quality: the coursing is less regular, and blocks are less well cut and lack the ridged surface tooling. Between the corner turret and the farmhouse, three bastions – two rectangular and one semi-circular – project out from the wall. As the bastions are bonded into the wall and their coursing also matches, it appears that the wall and the bastions are of a single build.

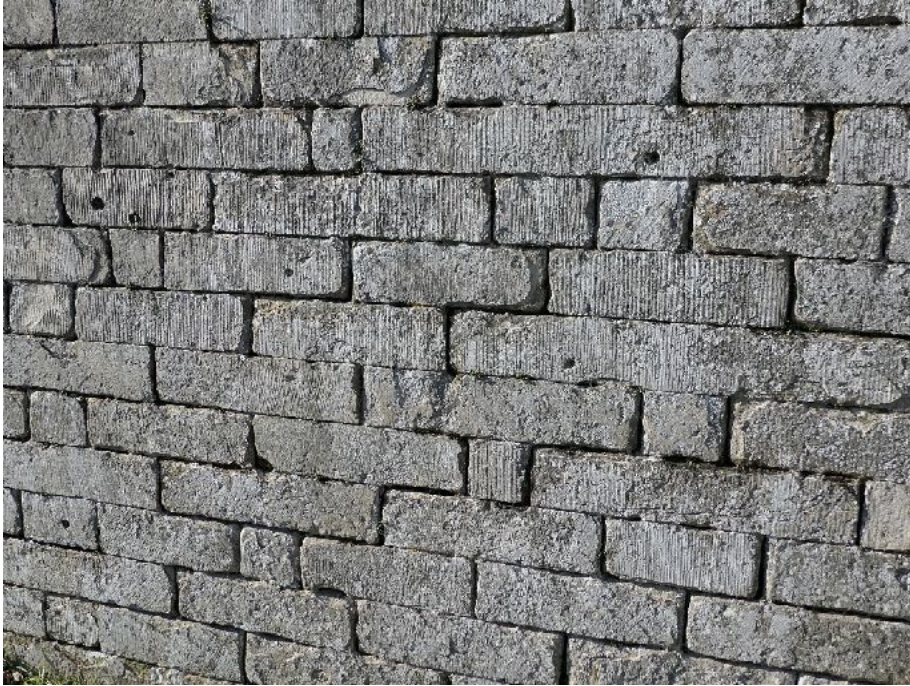
Figure 18. Ridged tooling on the ashlar masonry of the bastioned wall.

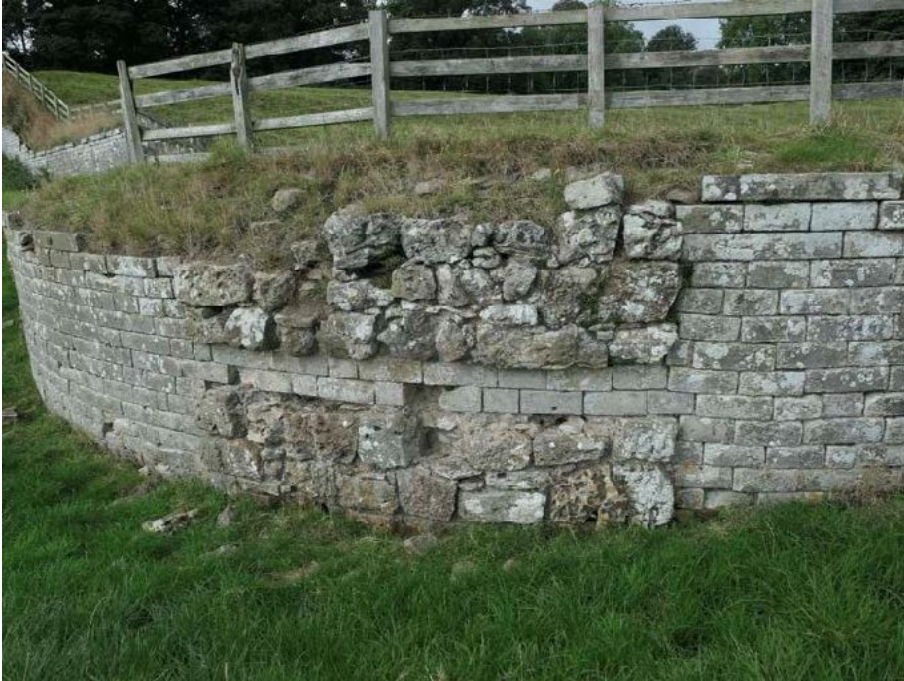
Figure 19. Bands of rusticated masonry in the half-moon bastion.

Between the corner turret and the pavilion, a half-moon bastion, embellished with bands of 'wild' rusticated stonework, projects outwards from the wall (Fig. 19).

Note that the lower stone in Fig. 19 displays the same ridged tooling as is apparent on the face of the retaining wall which contains the half-moon bastion at the south-east end of the

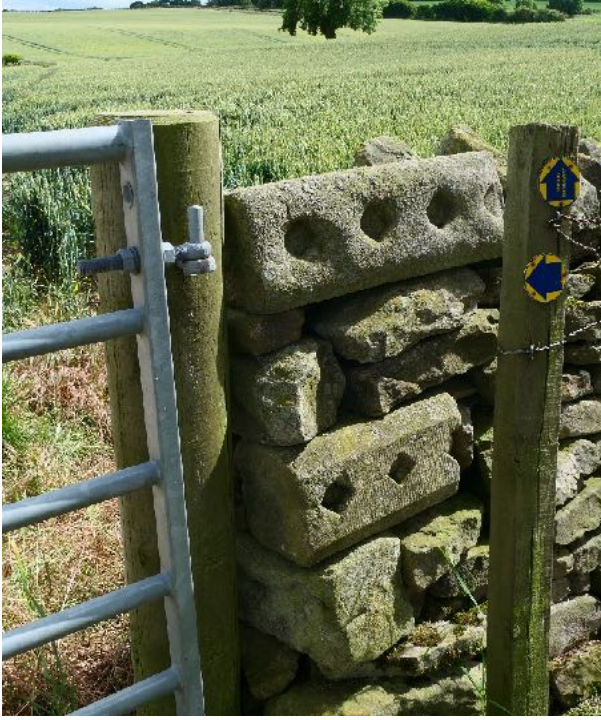
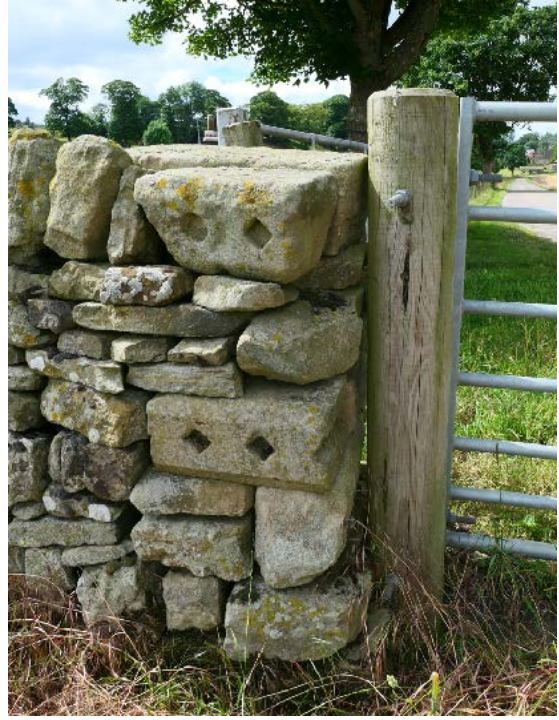
Figures 20 (left) and 21 (right). Ashlar blocks with diamond-shaped incisions re-used as decorative elements in modern field gateways.

Attention has already been drawn to stone blocks with diamond-shaped incisions, now incorporated into field walls at several locations about the farm and it is suggested that these were supports for fences made of light wooden palings like those drawn by Buck round the sides of the small parterre in front of the house (Figs. 20 & 21).

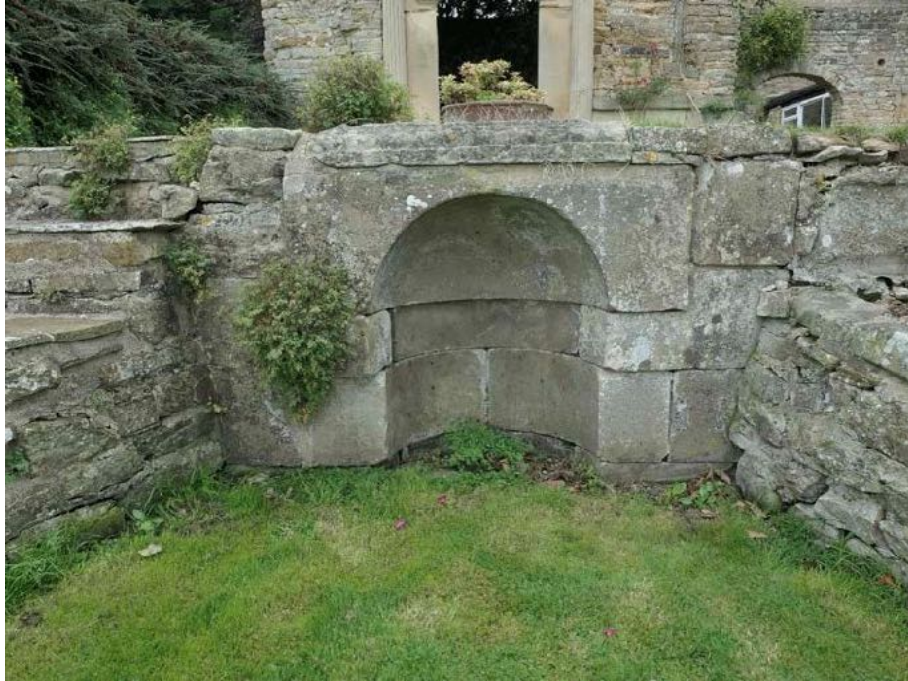
Figure 22. *In situ* niche between stone steps (on the left) and a rockery (on the right).

As can be seen from the plan (Fig. 2), the lowest terrace on the SW side of the garden curves round in such a way as to suggest that originally it continued in a north-easterly direction to join up with the terrace on the opposite side of the parterre. If so, then the short length of masonry wall containing the niche may have been part of a longer retaining wall at the head of the large parterre, linking the terraces on either side and providing a more impressive frontage, as seen from the other end of the garden, than would otherwise be provided by a simple grass-covered slope.

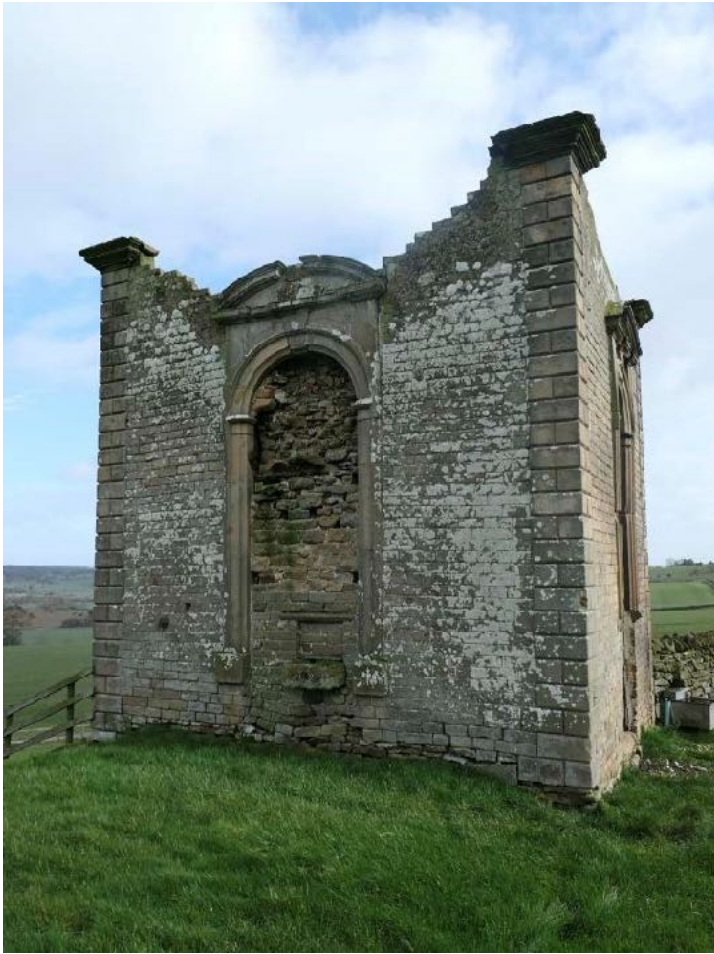
*Figure 23.
The blocked doorway of the 'Bell
Park' pavilion or tea-house.*

On grounds of architectural style, the pavilion is thought to date to c.1690/1700. It is square on plan with openings in all four sides: three windows and a door. The doorway (now blocked) was accessed by means of a short flight of steps. Inside there was a raised wooden floor and window seats below each of the three windows. High up in the walls, holes on the inside of the N and S walls would have held joists supporting a flat roof. Externally, the windows and doorway have identical frames topped by distinctive broken-arched pediments. The key-stones of the arched frames are decorated with stylised oak leaves (Fig. 24).

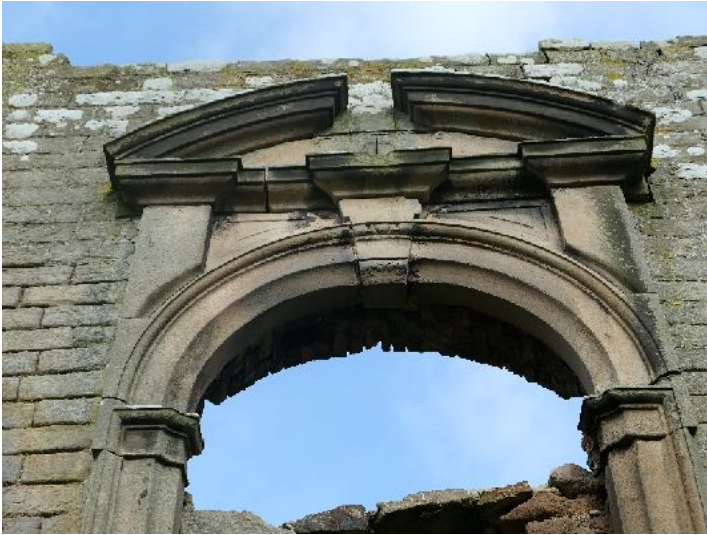
*Figure 24.
Pavilion or tea-house. Detail of a
window opening showing oak leaf
decoration on the keystone of
the arch.*

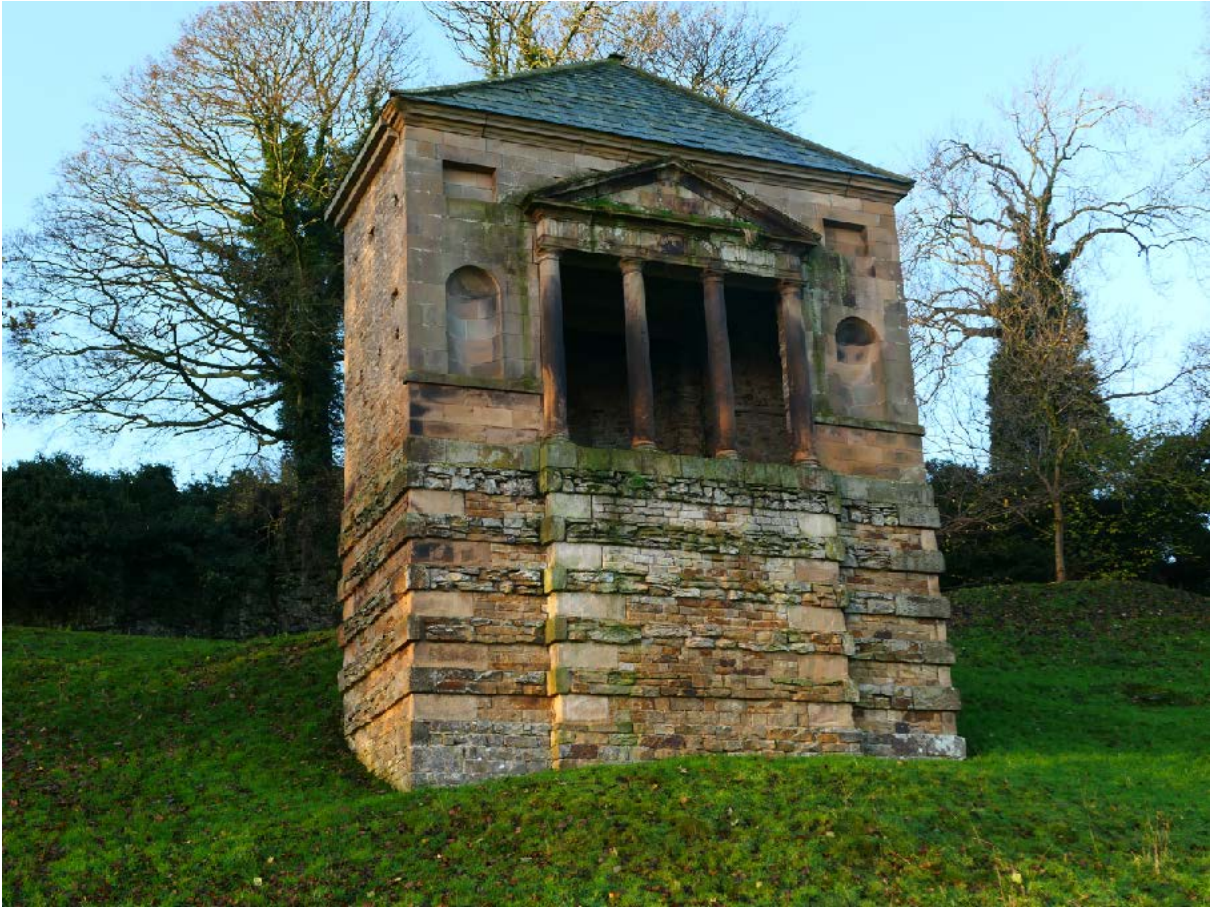
Figure 26. The temple-like 'summerhouse' or folly.

The temple-like 'summerhouse' overlooks the garden from a position half way up the steep slope leading to the crest of the escarpment edge (Fig. 26).

The building is of three bays, the central bay projecting slightly forward. It stands on a tall basement composed of alternating bands of coursed ashlar and rusticated masonry. The ashlar quoins at the corners are not symmetrical when seen from the front – on one side they are end-on to the viewer and on the other sideways on. Was this deliberate or due to a misunderstanding of the architect's intentions by the local masons?

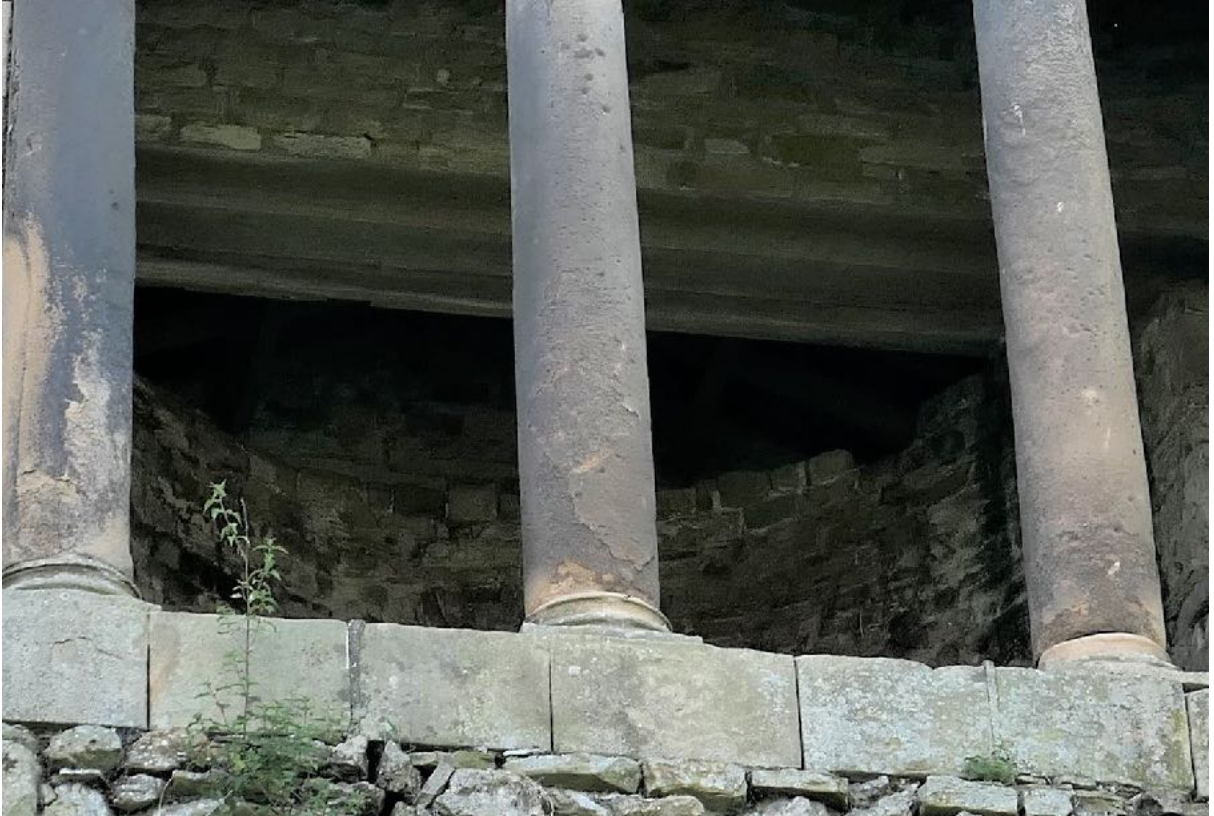
Figure 27. The apsidal wall towards the rear of the 'summerhouse' or folly is only dimly visible from the ground.

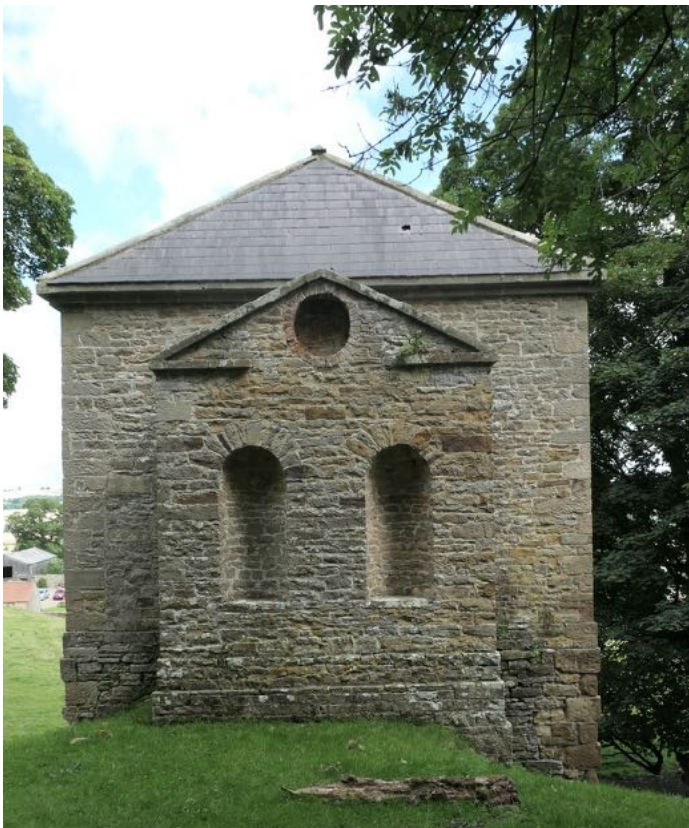
Figure 28. 'Summer house', rear view.

At the back of the building, a narrow range projects outwards to accommodate the apsidal structure within (Fig. 28). It is of coursed masonry embellished with two tall, round-headed, niches and a blind oculus edged in brick set in an open triangular pediment above. Originally, access to the building was by means of a narrow doorway (now blocked) in the wall to the left of the projecting range.

The pyramidal roof is of Westmorland slate except for the rear portion which has been replaced in Welsh slate.

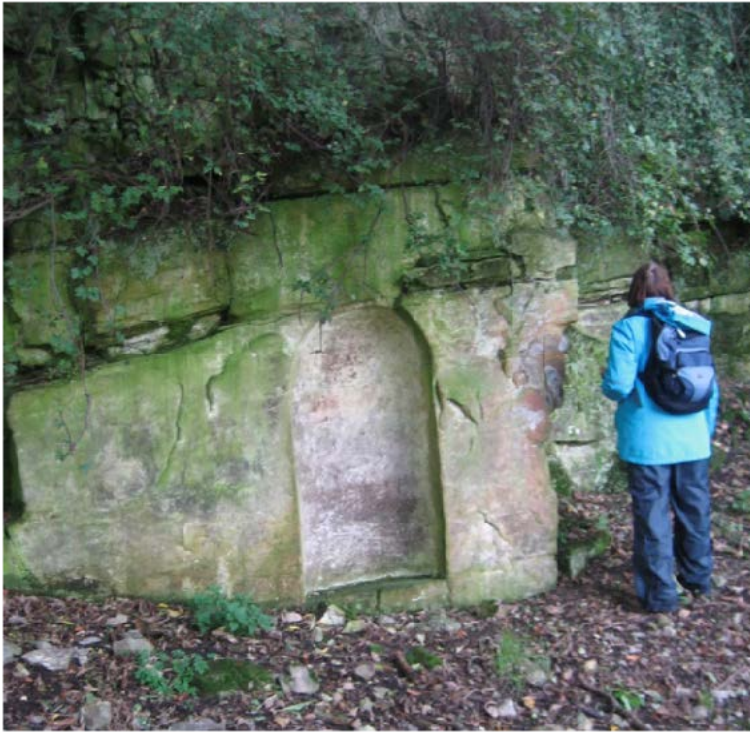
*Figure 29.
Niche carved into the rock face
behind the folly.*

Behind the folly, a round-headed niche has been carved into a vertical rock face produced by quarrying (Fig. 29). Although the quarrying cannot be precisely dated it is certainly older than the construction of the folly, as we shall see. The rock-cut niche mirrors the pair of niches which decorate the rear elevation of the folly. As it is invisible from the garden below and has no obvious purpose, it may simply be a *jeu d'esprit* carved by the quarrymen.

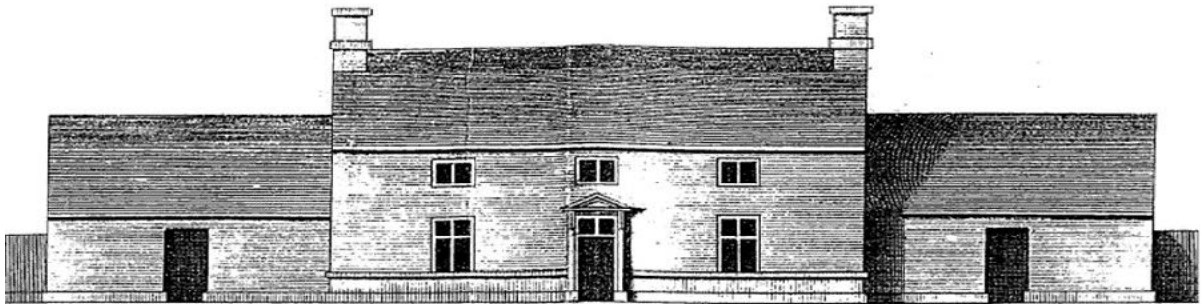
Figure 30. Daniel Garrett's design for a farmhouse from 'Designs, and Estimates, of Farm Houses, &c for the County of York, Northumberland, Cumberland, Westmorland, and Bishoprick of Durham', 2nd edn., 1759.

The design of the farmhouse that replaced the Jacobean hall derives from Daniel Garrett's book '*Designs, and Estimates, of Farm Houses, &c for the County of York, Northumberland, Cumberland, Westmorland, and Bishoprick of Durham*', first published in 1747 (Fig. 30).

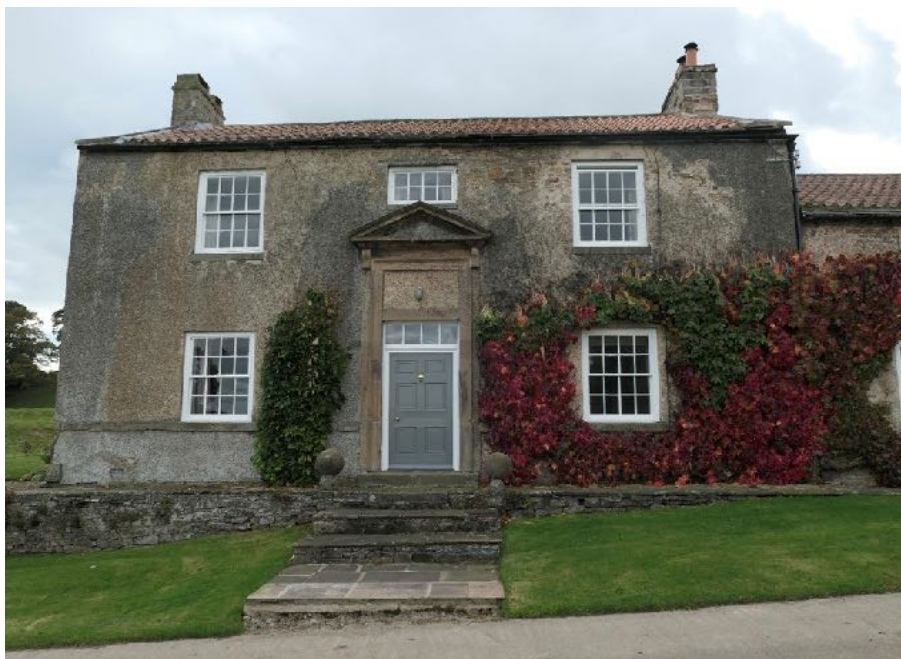
Figure 31. The north-facing facade of the farmhouse. Note the decorative stone balls which may originally have topped gate pillars belonging to the garden shown in Buck's drawing.

The oversized doorcase with its triangular pediment, the horizontal band surmounting a plinth course at the base of the facade, the fenestration and the chimneys in the gables, are all strongly reminiscent of Garrett's published design (Fig. 31).

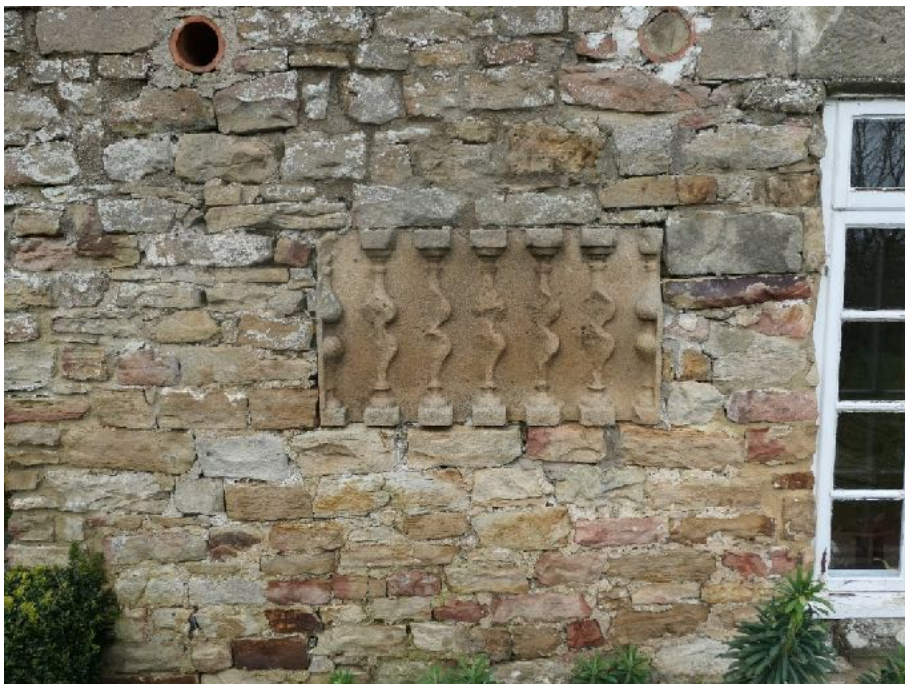
Figure 32. Demi-balustraded panel ex situ in an outhouse wall.

This is a far more likely scenario than one which envisages a grand new country house, whether completed or not, as having been lost in the fire. For one thing, although there are pieces of early eighteenth-century masonry left on site that seem likely to belong to a lost building, they are not sufficient to justify the notion of a large and entirely new house. One such piece is a demi-balustraded panel set incongruously in the outside wall of a nineteenth-century animal shed or outhouse that was partly demolished in the 1960s (Fig. 32).

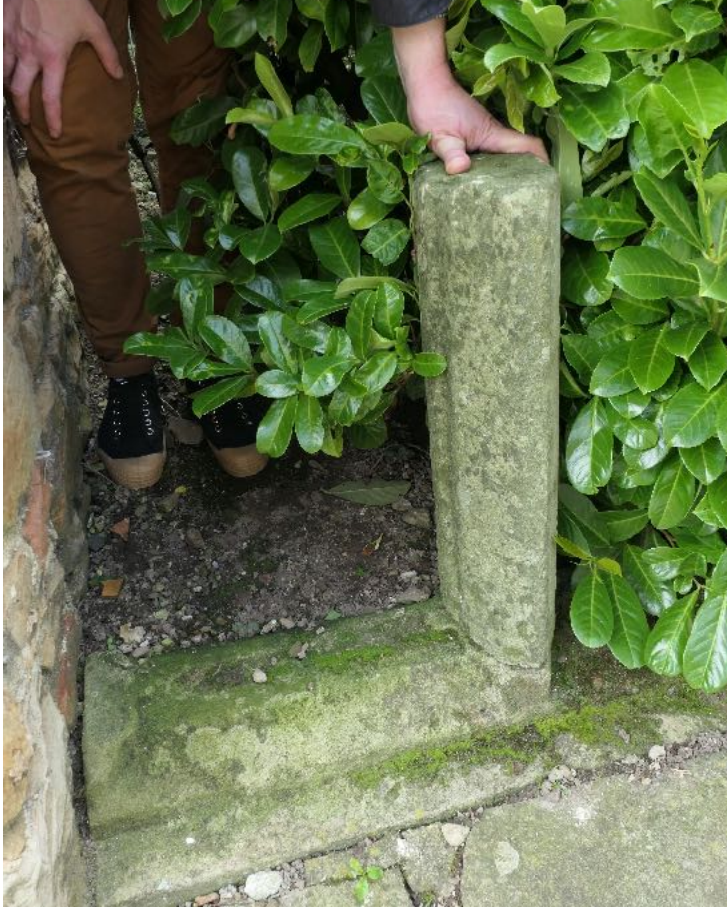
*Figure 34.
Sill and mullion of window from the
Jacobean house re-used in a rockery.*

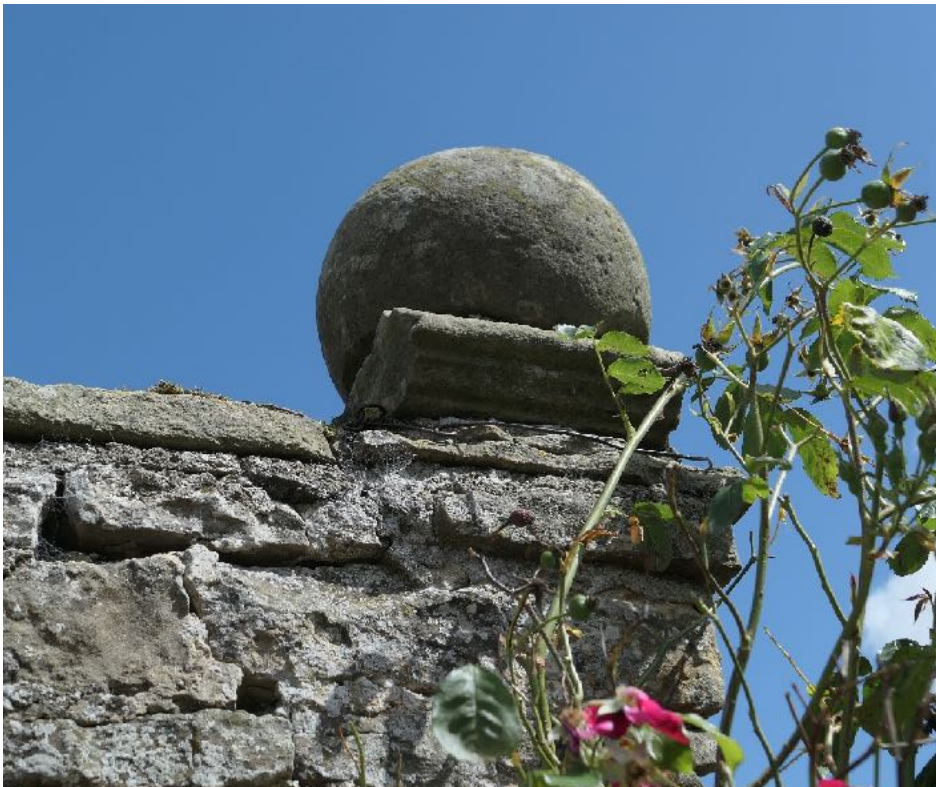
Figure 35. Decorative stone ball re-positioned on top of a garden wall.

By contrast, fragments of architectural masonry belonging to the Jacobean house, including decorative stone balls and pieces of mullioned-and-transomed windows, can be seen re-used in rockeries and flower beds around the site (Fig. 31, 33, 34 & 35). Several such pieces were recovered in the 1960s when a rockery was being built in the garden to the SW of the farmhouse. Very likely this was rubble resulting from the demolition of what remained of the Jacobean house after the fire. Probing with a garden fork suggests that there could be a great deal more rubble buried under the upper lawn next to the farmhouse (Fig 41).

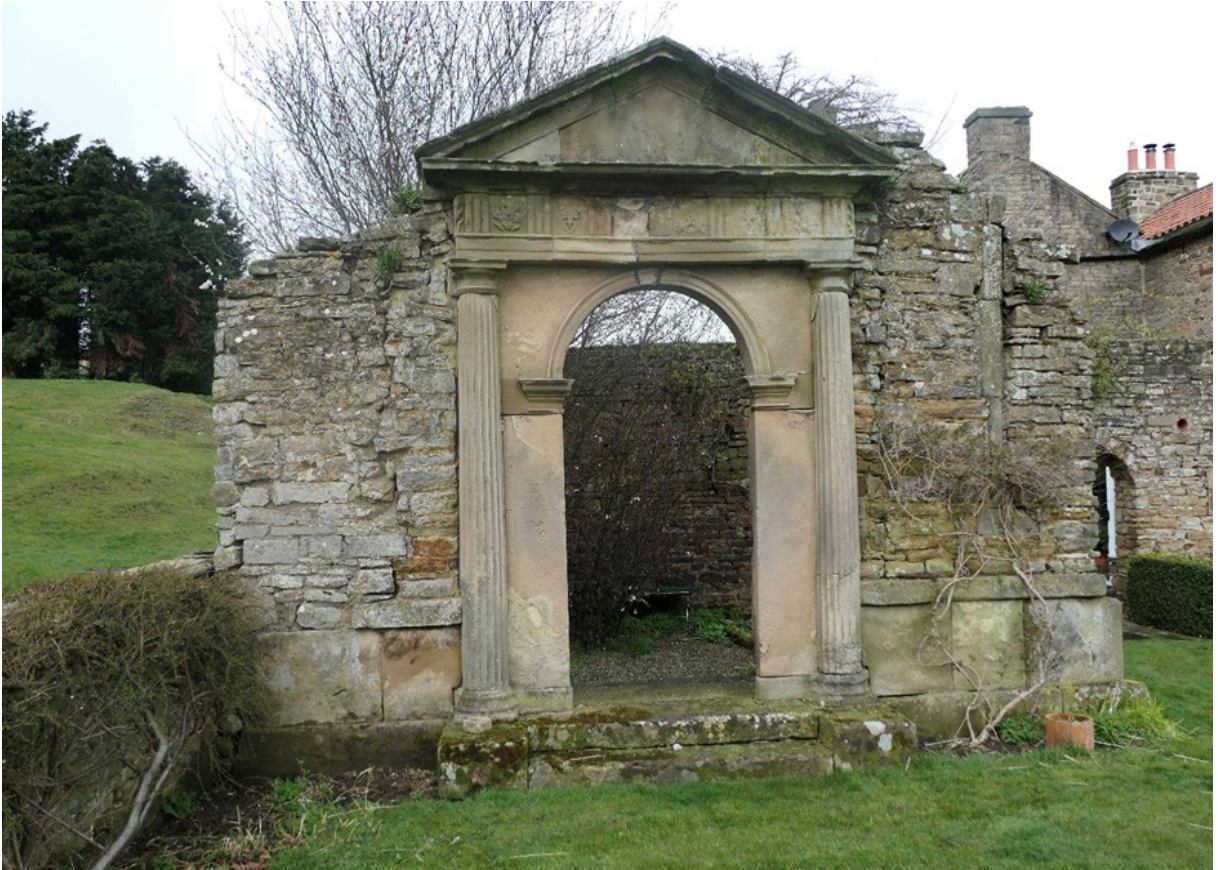
Figure 36. Doorway with Palladian-style doorcase.

On the lawn to the S of the farmhouse is a doorway set in a 6m length of rubble walling which has traditionally been held to be a surviving part of the Jacobean manor house. A Palladian-style doorcase, with fluted Doric half-columns and a richly ornamented entablature and pediment, dates to c.1730/40. The fine ashlar plinth at the base of the wall, like the Palladian doorcase, is not shown on Buck's drawing and so it too must be dated later than c.1720 (Fig. 36).

Careful examination of this wall shows that it is a composite structure, consisting of masonry of more than one period, and much time has been spent discussing and analysing it.

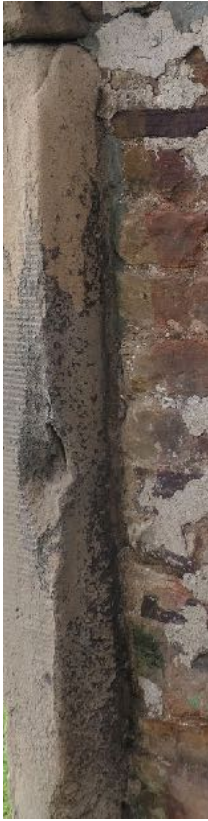
Figure 37.

The faint shadow of a wooden door showing as a pale strip against the fire-reddened masonry.

As the stonework of the internal face shows clear signs of reddening by fire, it can reasonably be assumed that the wall was standing when the house burned down in 1750. Further indications of fire damage can be seen on the splayed reveals of the doorway opening where a vertical strip of paler sandstone, evidently unaffected by heat, contrasts with the adjacent fire-reddened stonework (Fig. 37). This shows where a wooden door, some 110mm thick, had stood at the time of the fire, protecting the masonry from the intense heat.

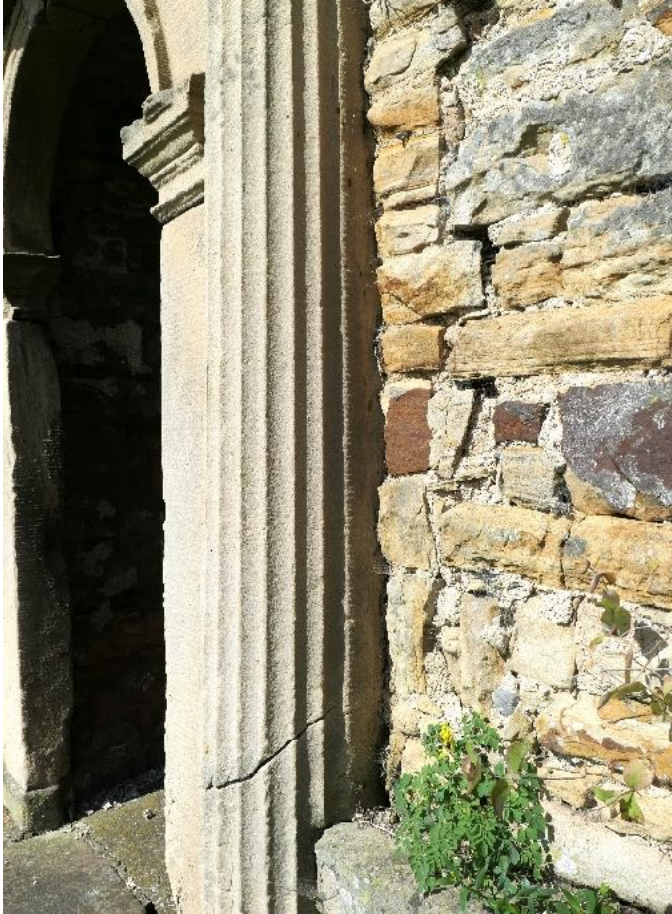
*Figure 38.
Lip on the edge of a column
indicating the thickness of a coat of
render.*

Amongst other improvements, it seems that Garrett intended that the exterior stonework of the Jacobean house should be covered with render and the old mullioned windows replaced by more fashionable sashes. The evidence for this is as follows. On both sides of the doorway, the carving of the fluted columns stops with a slight lip a couple of centimetres short of the wall surface (Fig. 38). We suggest that this gap represents the thickness of a coat of render. Again, it seems unlikely that the crude blocking of the mullioned window was intended to be seen and this too argues in favour of a rendered wall surface.

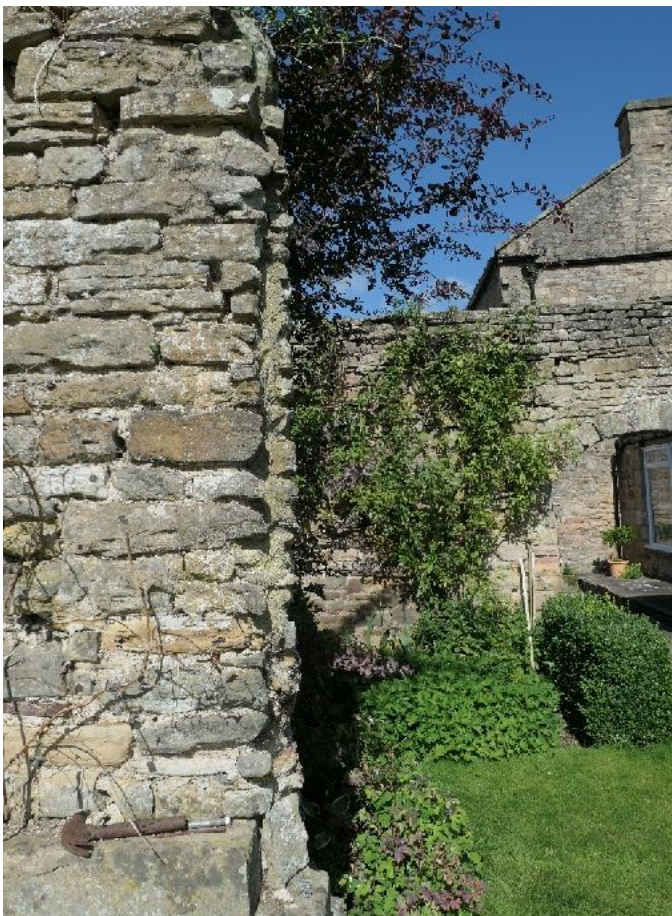
*Figure 39.
The rebate in the blocking of the
mullioned window designed to
house the frame of a sash window.
The hammer sits on the string
course of the plinth believed to
have been inserted by Garrett.*
