Gillingwood Hall, near Richmond, North Yorkshire,
and its historic garden:
an interim report

Tim Gates and Trevor Pearson

Scarborough Archaeological and Historical
Society
Report 62: 2024

National Grid Ref NZ 1710 0475
National Grid co-ordinates 41710 50475
North Yorkshire HER No. MNY40333

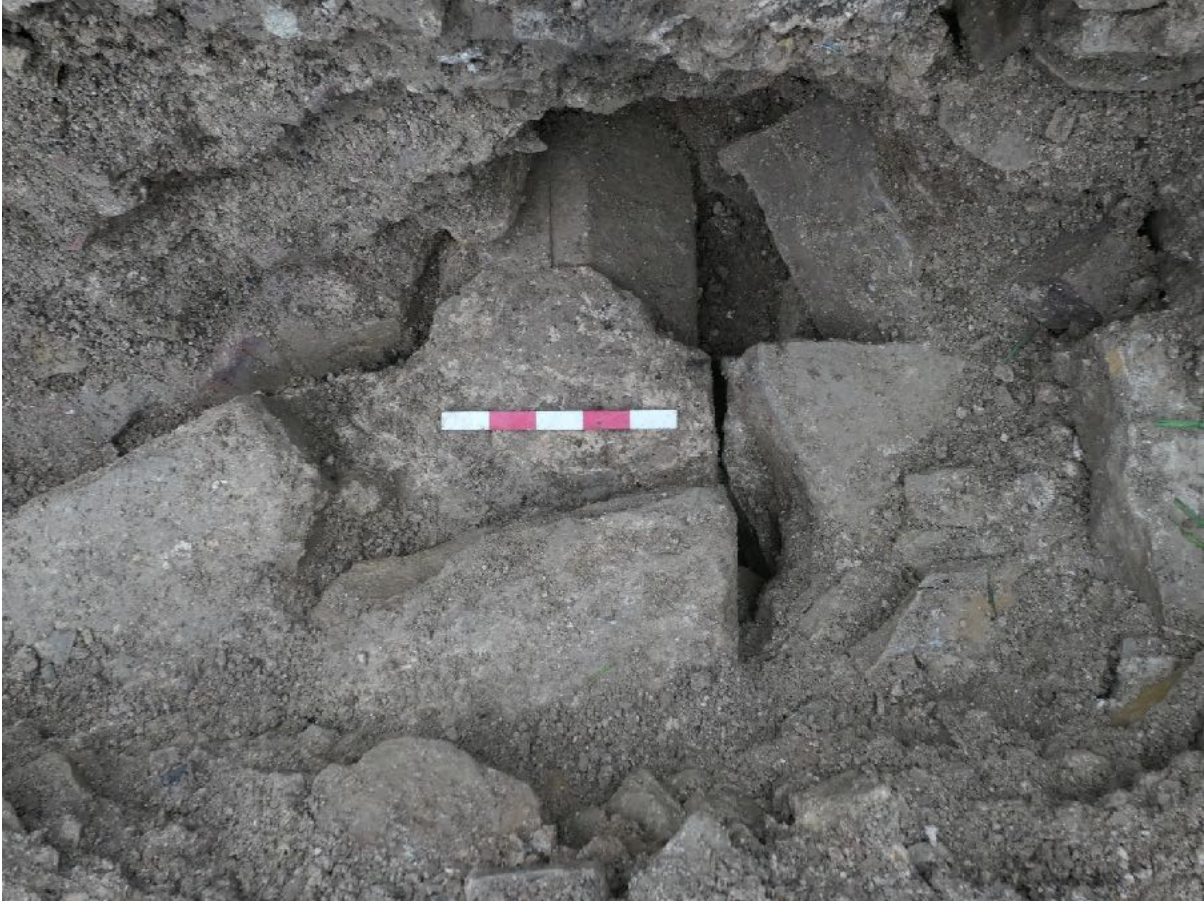
Figure 42. The finely carved and moulded window sill in situ. To the left of the scale the internal splay of the window opening can be seen.

The result was positive though not quite in the way that had been expected. Under a thin layer of turf and topsoil, a uniform deposit of demolition rubble sealed an *in situ* carved stone window sill at a depth of 90cms (Fig. 42). The end of the sill was moulded in a manner identical to the sills of the mullioned windows now incorporated into the rockery outside the sunroom which can only have come from the Jacobean house (Fig. 33 and 34). The buried sill was bonded into ashlar masonry which forming the internal splay of the window which can only belong to a previously unsuspected basement level of the early hall. Only a very limited portion of the outer wall face below sill was exposed in the excavation but enough to
